# FURE'S CABIN

## HISTORIC STRUCTURE REPORT

KATMAI NATIONAL PARK & PRESERVE

BAY OF ISLANDS, NAKNEK LAKE

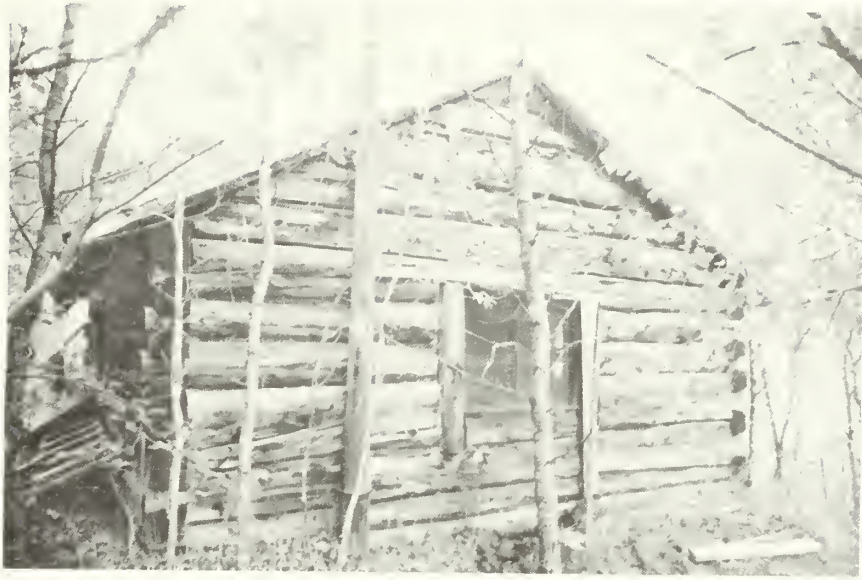
Photograph 3  
West Elevation: Note Deteriorated Condition of  
Roof Planks  
6/82 D. Snow

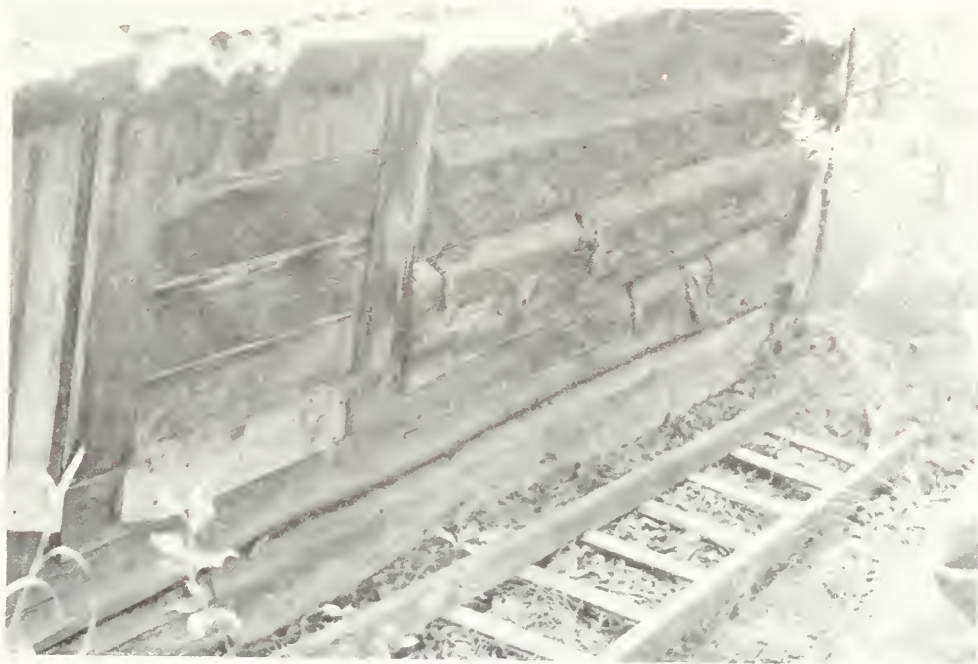
Photograph 11  
Roof Planks Ends at East  
Elevation  
6/28/83 D.C. Anderson

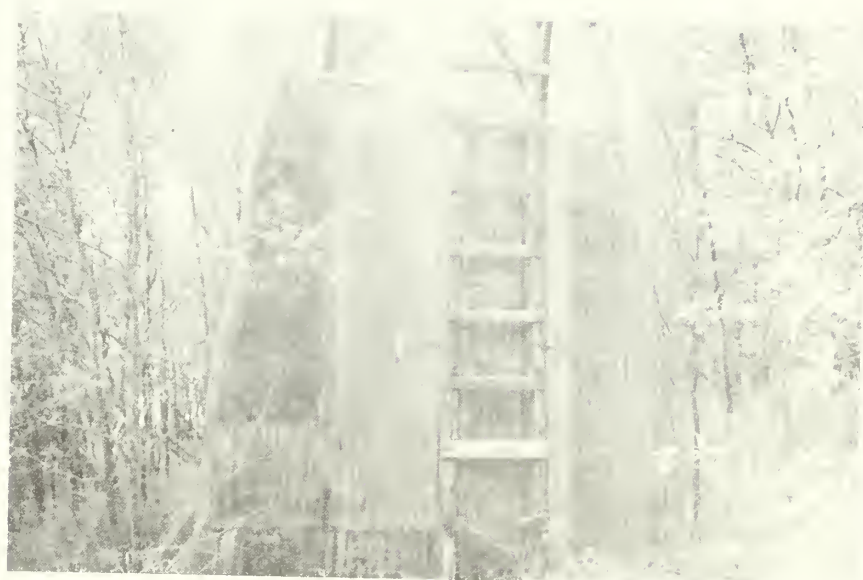
Photograph 46  
North Elevation of Windmill Tower  
6/83 D. Snow

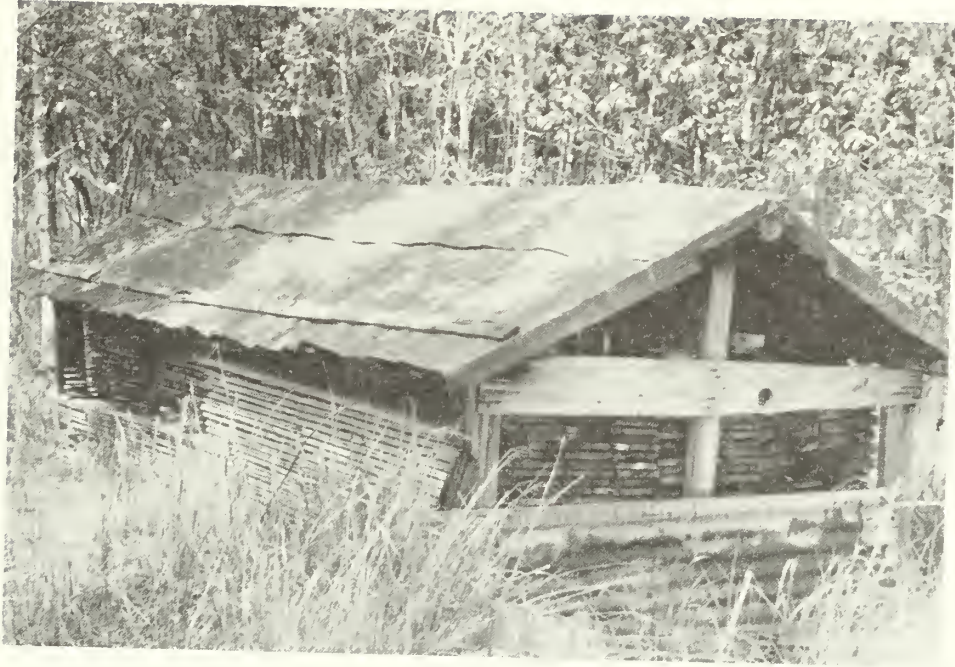
Photograph 49  
Storage Shed  
6/82 D. Snow

3. A storage shed for lumber, measuring about 4' x 15' and standing about 4' high, is about 50' south of the cabin. This structure consists of 2x4 studding and a tin roof. It was built without walls. Condition of the shed is good.

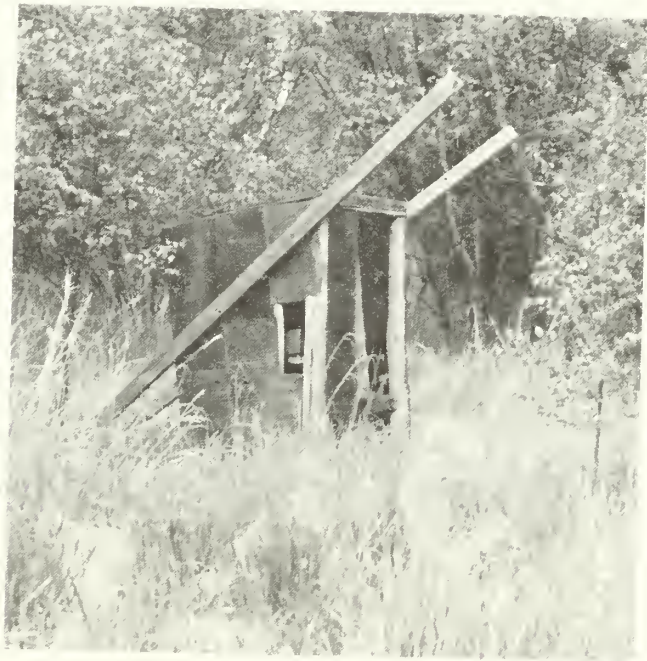
Photograph 50  
South Elevation of Out-House  
6/82 D. Snow

5. An outhouse is about 20' southeast of the cabin. It is constructed of planed lumber and poles. The condition is good.

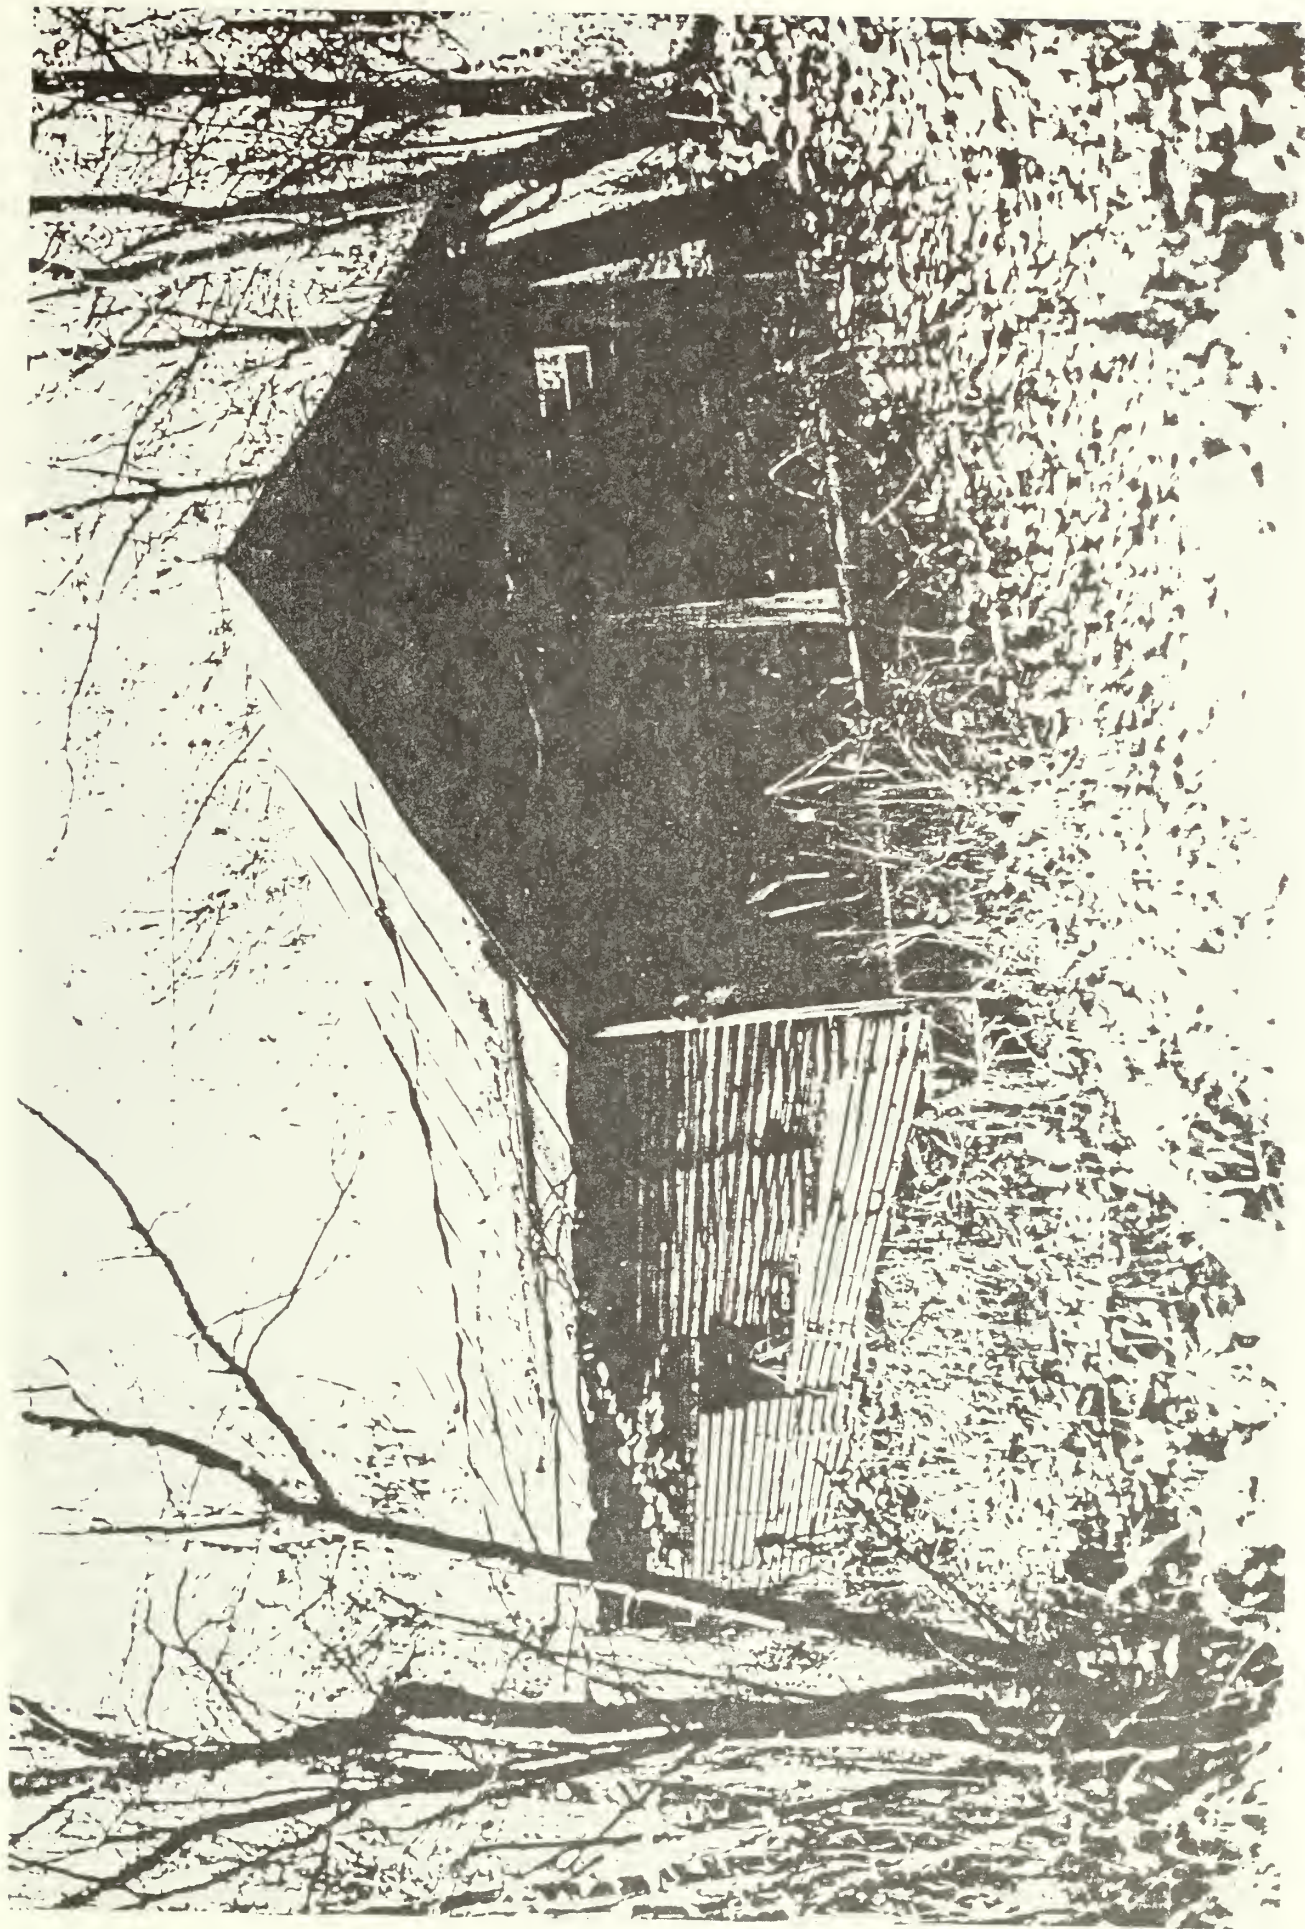
Pure's Cabin, Katmai National Park and  
Preserve, Alaska. NW view of storage shed  
for lumber. NPS photo, Sept. 1983. Negative  
filed at Alaska Regional Office, NPS,  
Anchorage, Alaska. J. Estus.

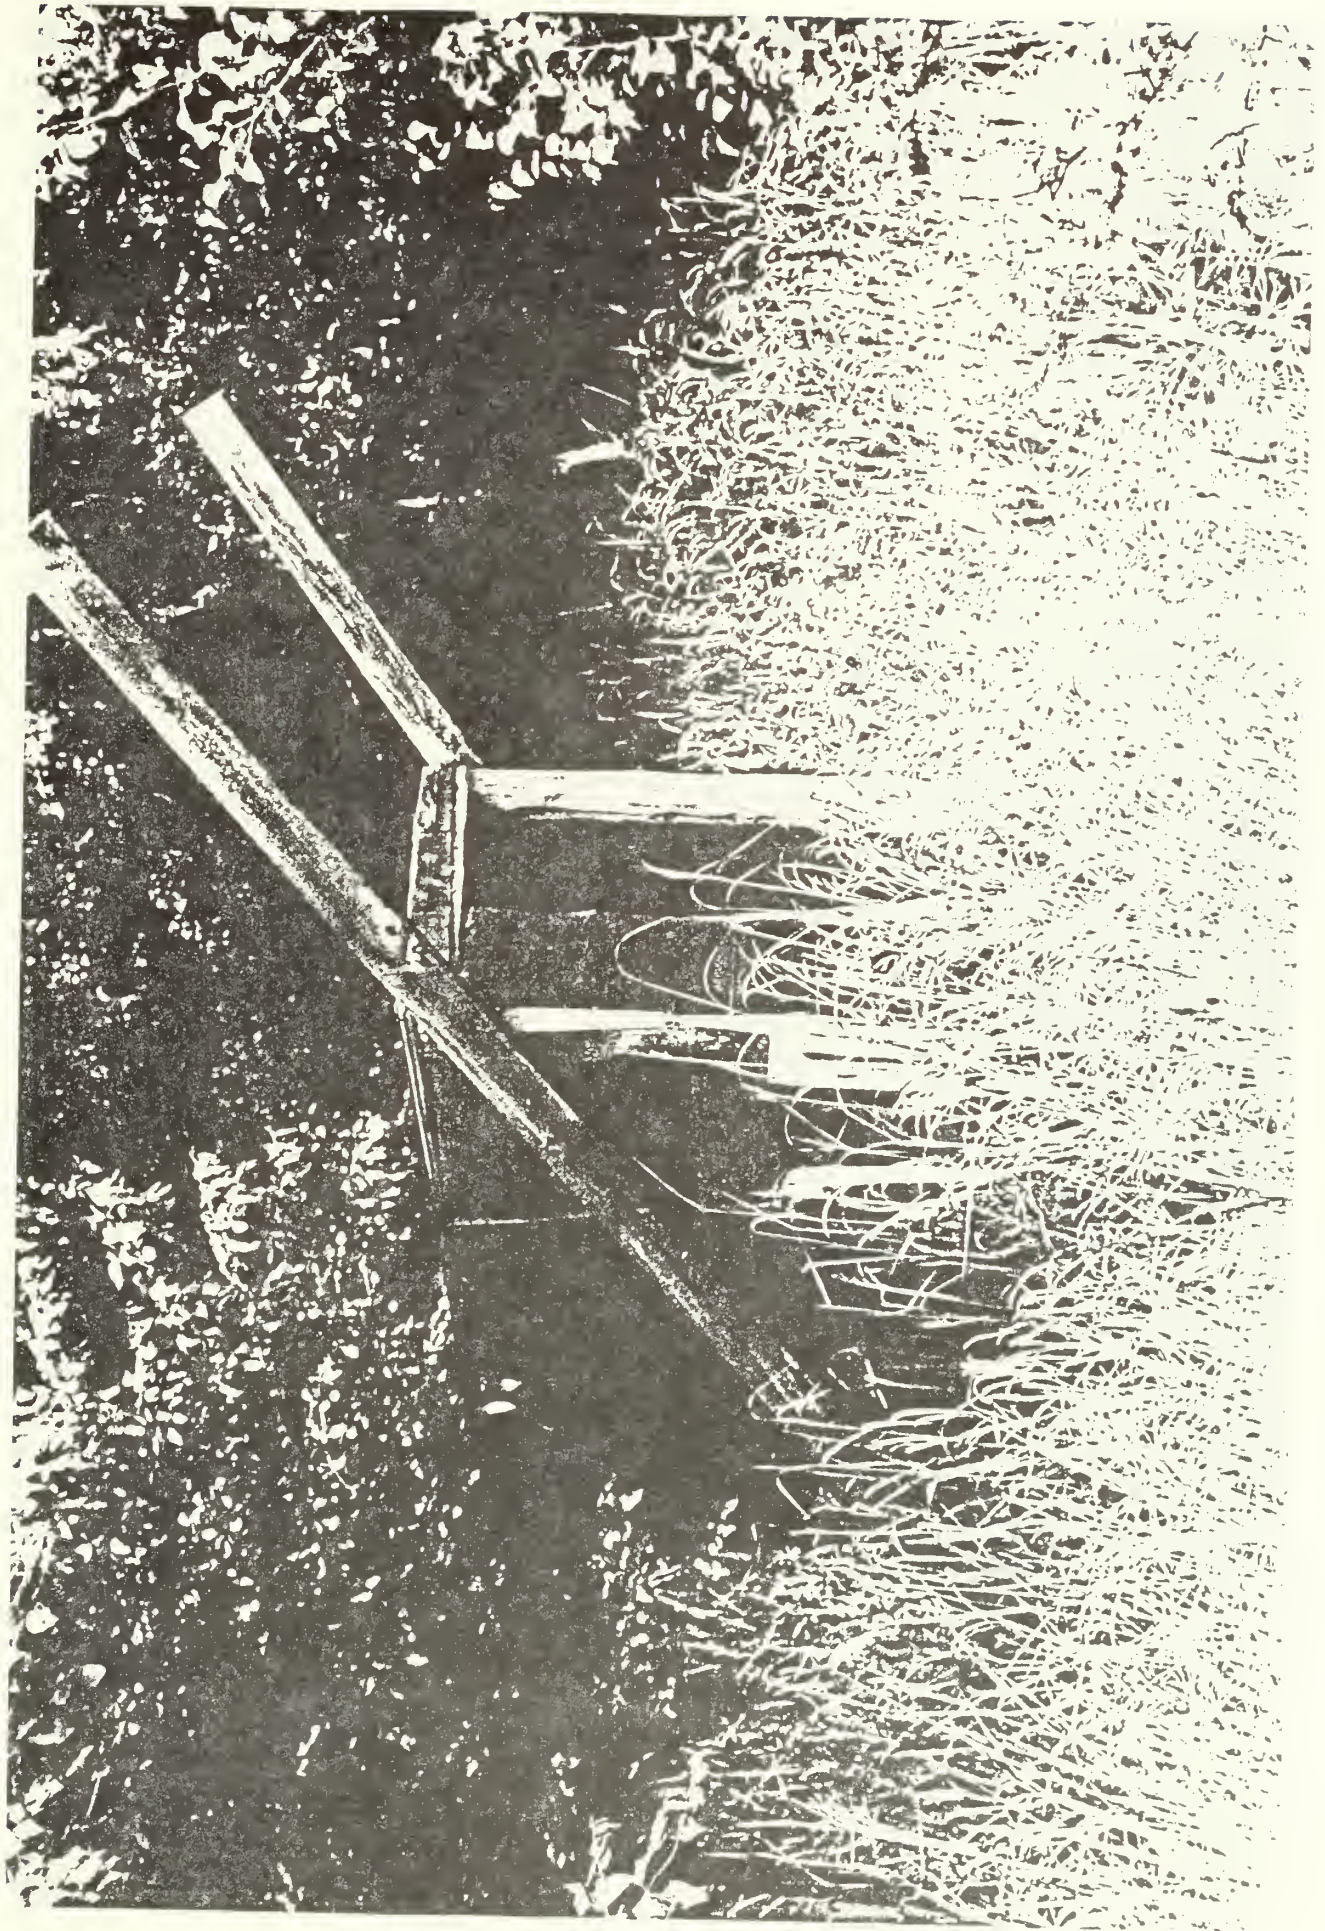
Fure's Cabin, Katmai National Park and  
Preserve, Alaska. Outhouse located about 20'  
southeast of cabin. NPS photo, June, 1983.  
Negative filed: Regional Architect's files,  
Klondike Gold Rush NHP, Skagway, AK. D. Snow
